# RADIOGRAPHIC PROFILING

## Attemperator Assemblies

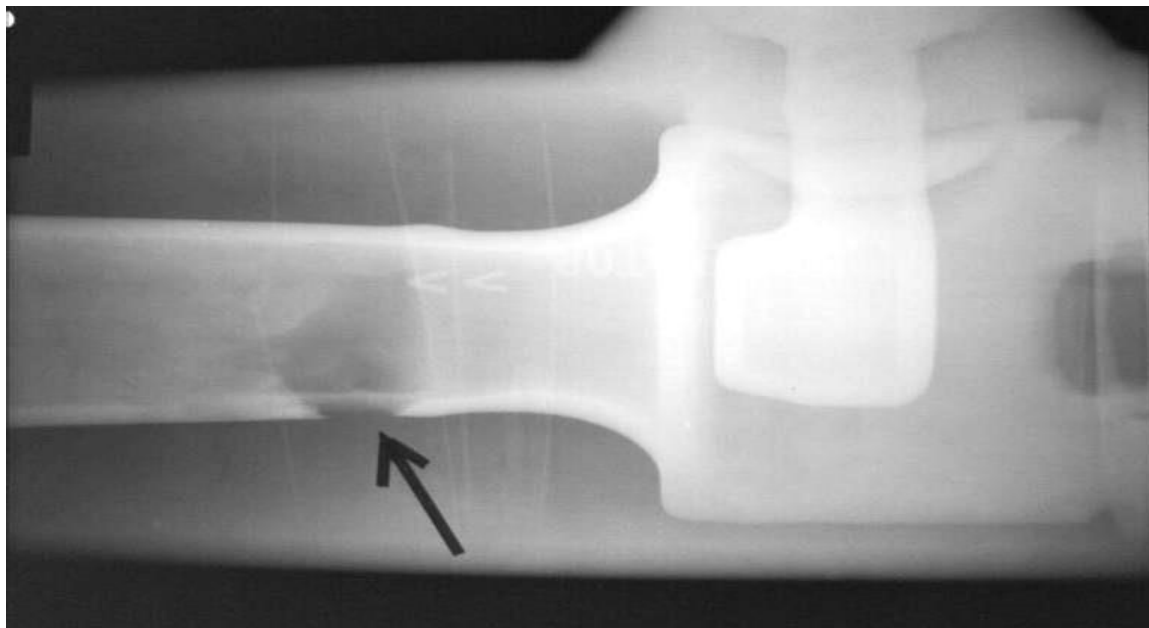
Radiograph of Ruptured Spray Nozzle Assembly

While typically applied for the evaluation of weld quality, radiography also has useful applications when utilized as a profiling technique. One example involves the evaluation of components that are inaccessible, such as internals of desuperheater or attemperator assemblies

- Detect cavitated areas
- Discover obstruction or debris collection
- Spray liner head/nozzle degeneration
